**Subject:** Suite C 1718 N. Cherokee St. - HPOA Service Center  
**From:** Sergio Urena <surena@streetplus.net>  
**Date:** 01/09/2018 03:23 PM  
**To:** Karina Beltran <kbeltran@charlesdunn.com>  
**CC:** Matthew Severson <Matthew@hollywoodbid.org>, Rich Sarian <Rich@hollywoodbid.org>, Ken Nakano <knakano@streetplus.net>

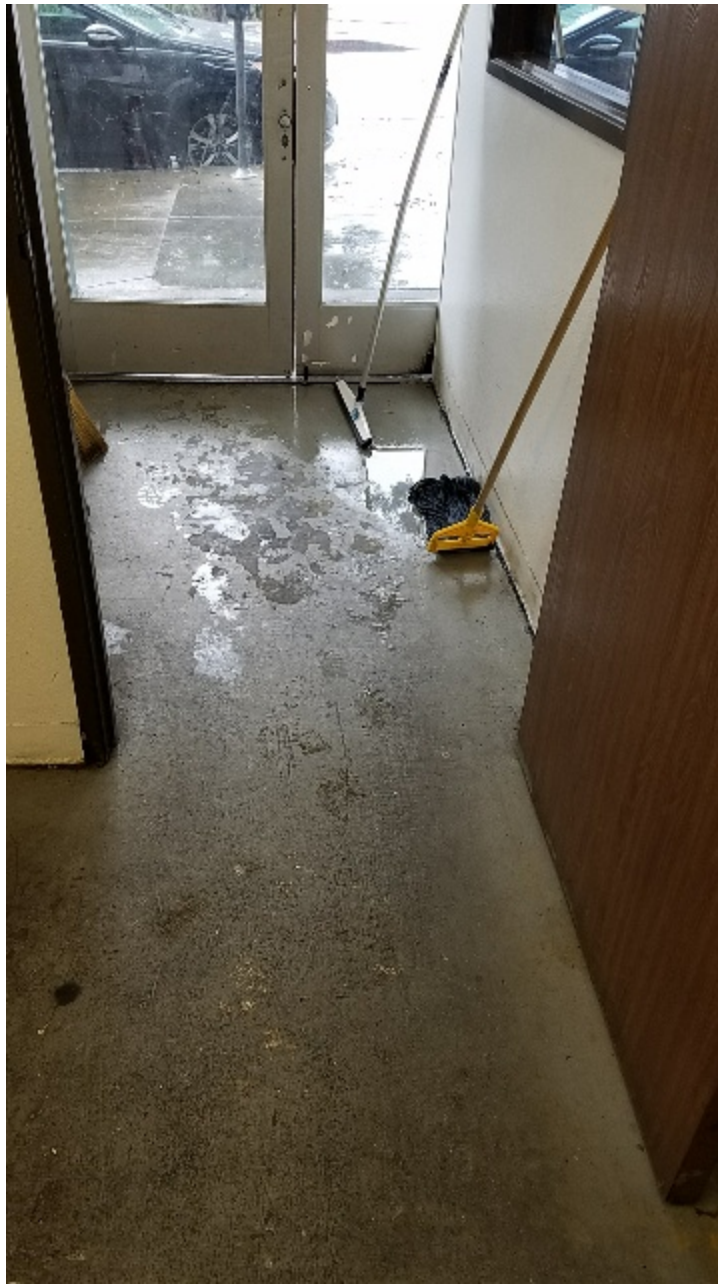
— 20180109\_145938\_resized.jpg —

Thank you for responding to our need so quickly. I took the pictures of where the water has gone to inside the service center. These unfortunately are after we have cleaned-up the water. However, they do show the areas that we are talking about. I believe that once the water passing thru the front door, it then seeps thru and underneath the dry wall and into the other rooms.

We are currently trying some sand bags to see if they help for today's remaining rains.

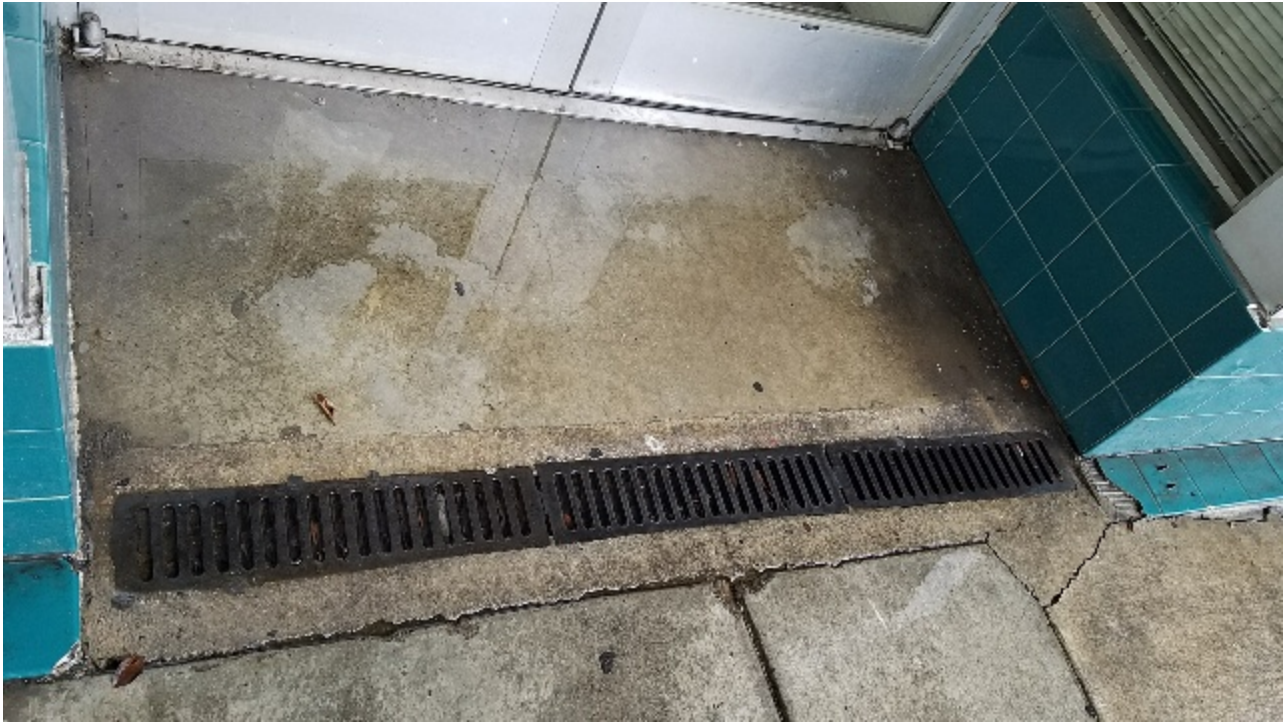
— 20180109\_145835\_resized.jpg —

The picture that shows a black metal grate (pic 145835) is what should be draining the majority of the water. We have tried opening it to clean out the debris but I believe they are integrated into the concrete. The side walk is also an issue, due to a tree root lifted the front slab and directing the water back towards the door.
